**2023 Annual CCR Landfill Inspection Report
Byproduct Storage Area B
St. Johns River Power Park**

JEA/St. Johns River Power Park

GL19124481.001

January 2024

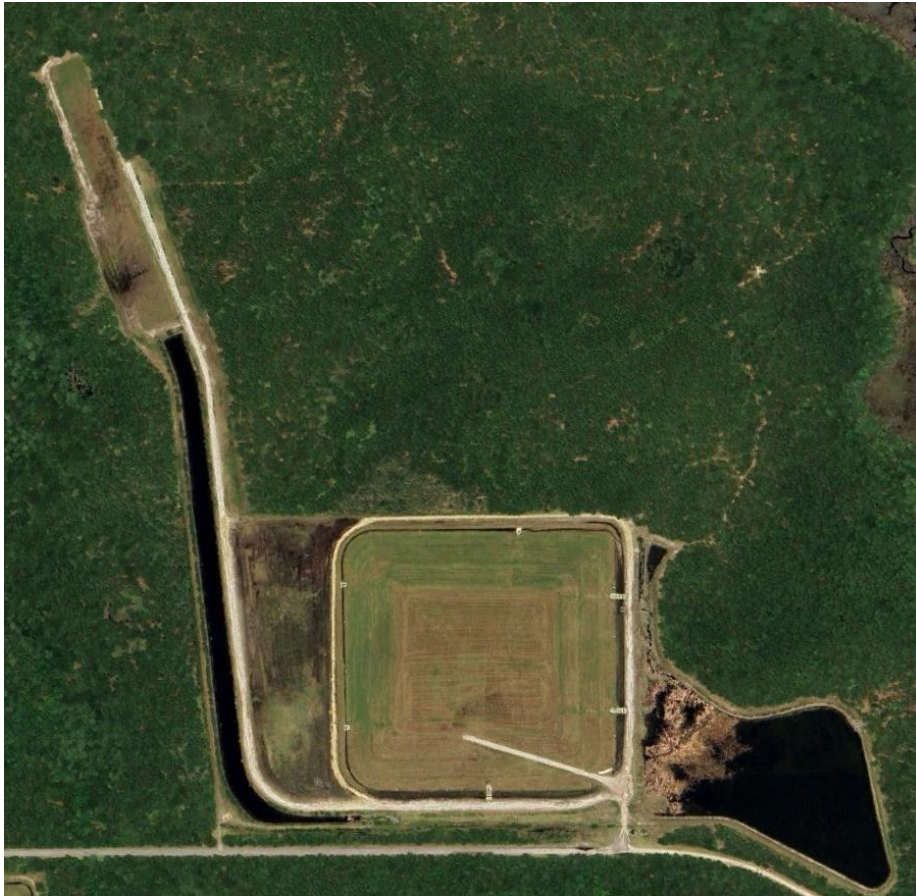
Figure 2: Aerial Photograph (Google Earth¹)

The primary changes in the geometry of BSA-B since the past annual inspection are due to the closure construction of the BSA-B and the relocation of materials from the western portion of the Phase I footprint to the closed BSA-B. Closure construction entailed the construction of bench ditches, stormwater management features, and geomembrane capping of CCRs. A recent aerial photograph of BSA-B (dated June 2023) is provided on Figure 2.
