## TECHNICAL SPECIFICATION

### B53 – UAT BUS BAR CONNECTIONS BRANDY BRANCH GENERATING STATION (BBS)

#### Scope of Work

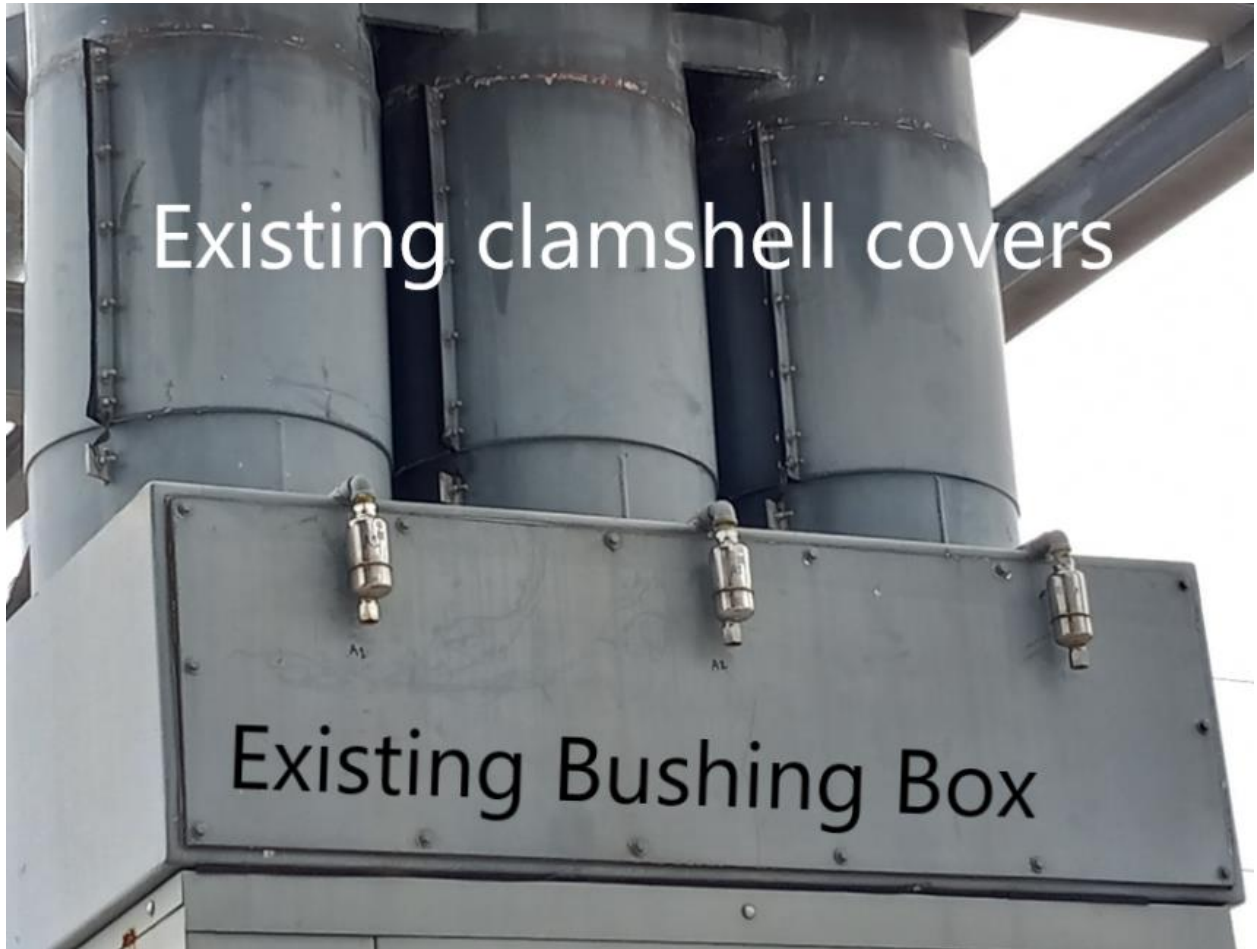
**Existing clamshell covers on top of existing bushing box.**

- Installing existing clamshell covers onto existing bushing box / IPB.
- Swapping cables on transformer taps if and only if there are phasing issues.

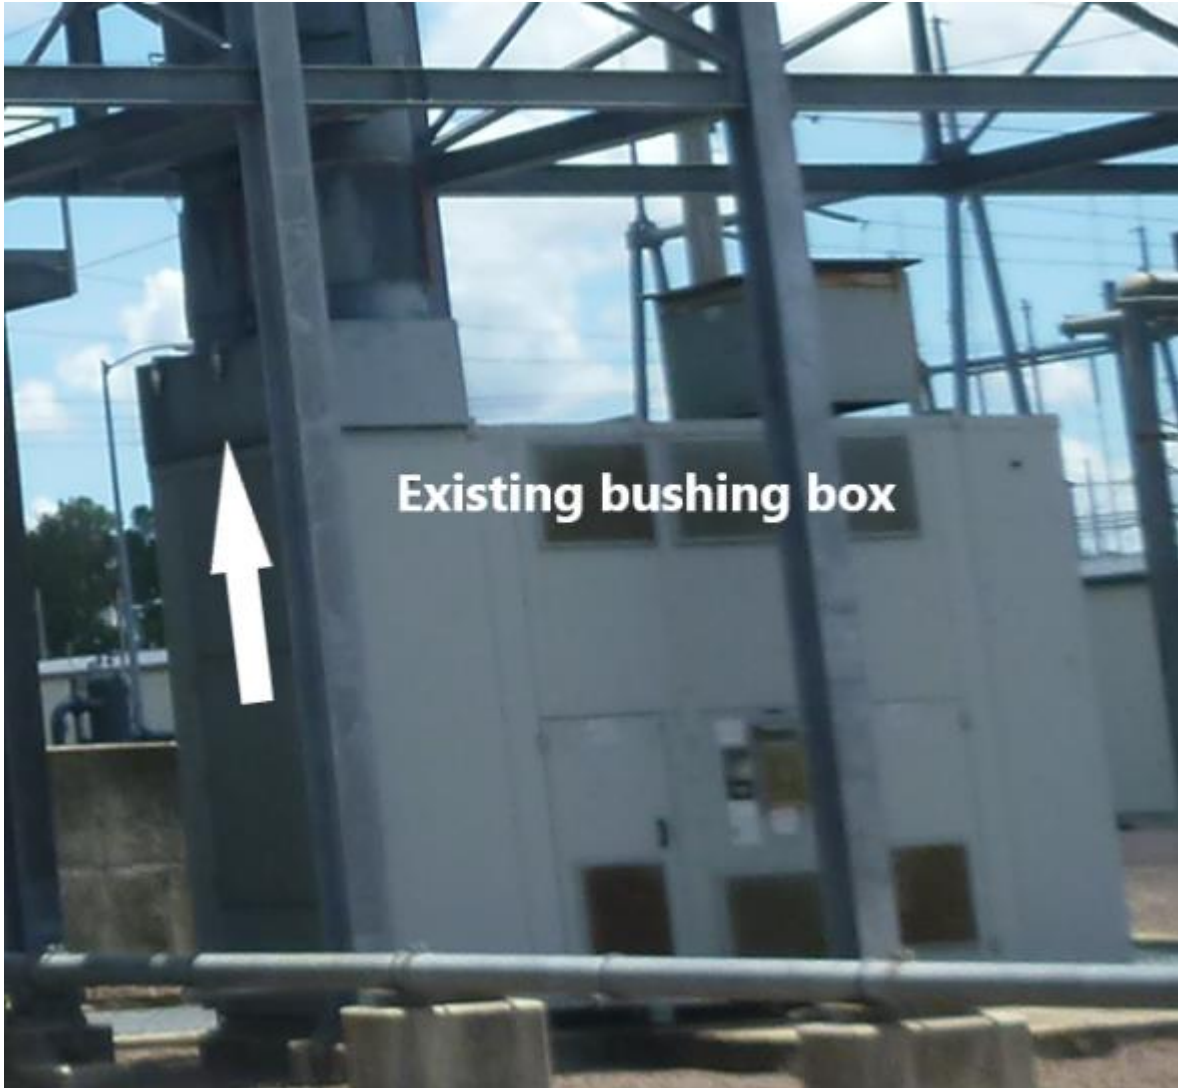
**Profile of transformer pointing out existing bushing box.**

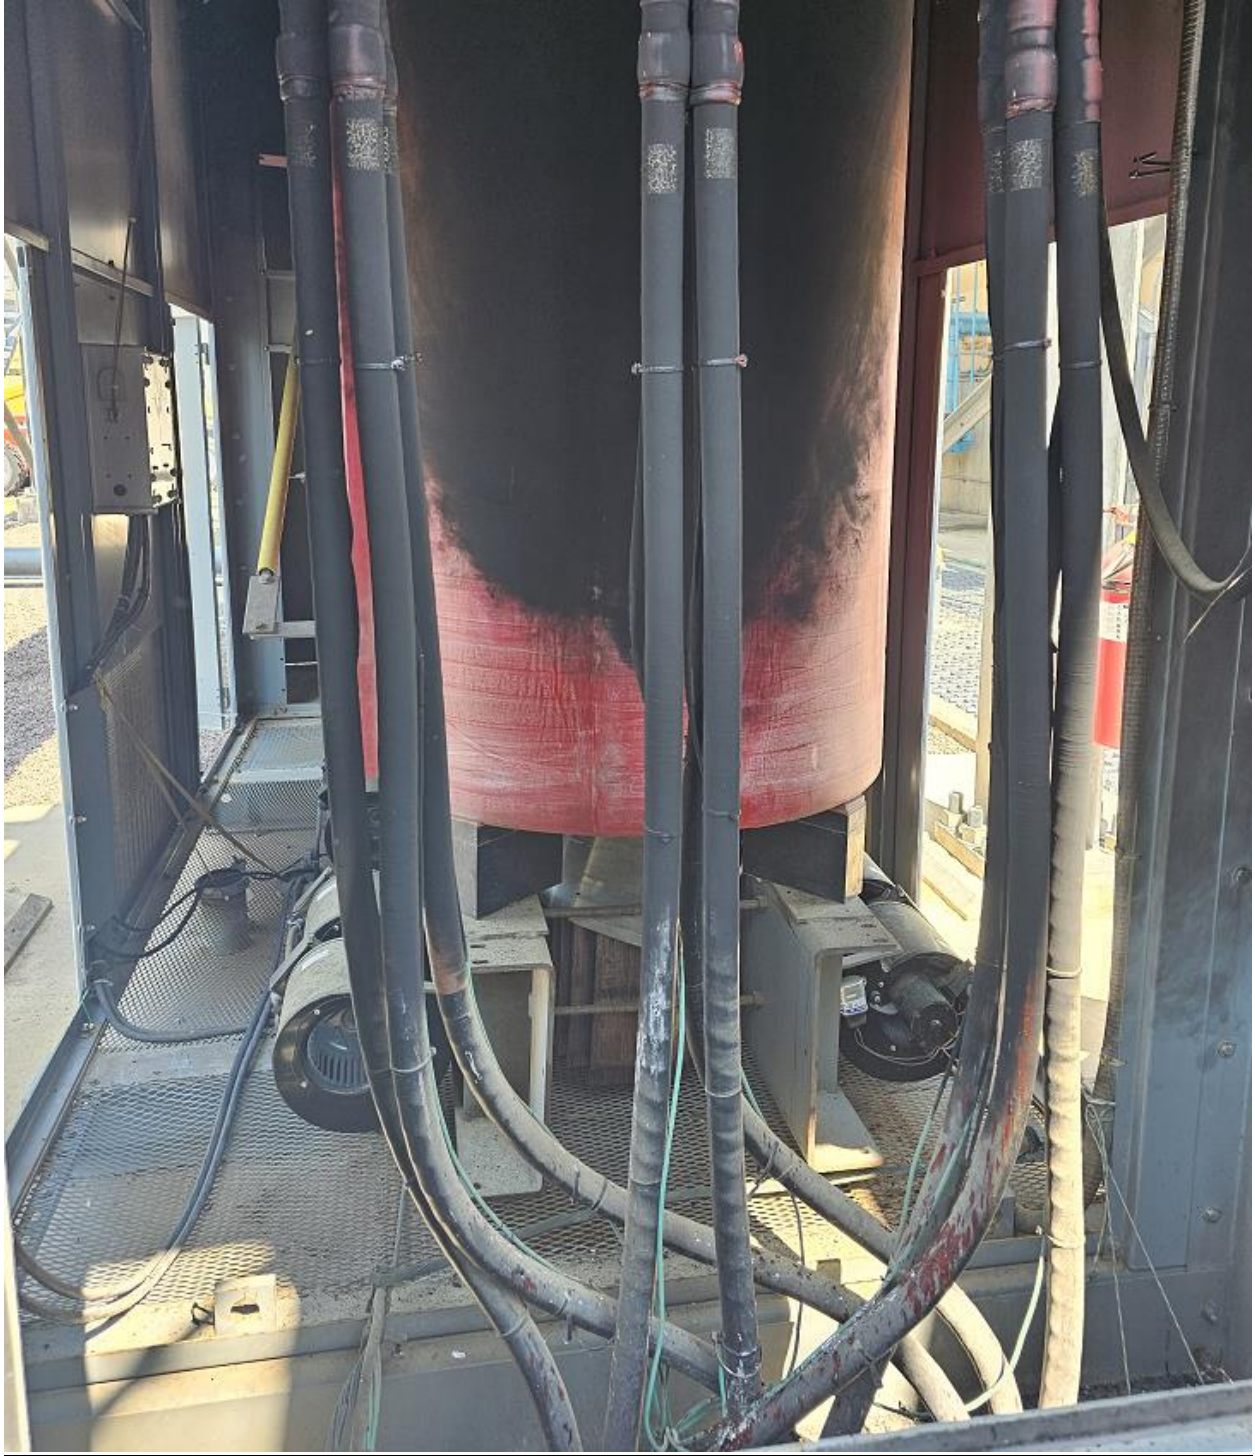
**Secondary Medium Voltage 750MCM Cables.**

The secondary (4160V) cables shall be tested with a VLF withstand test voltage according to IEEE Std. 400.2-2013. The testing will be performed to 2400Vac (nominal phase to ground) as the cables will be connected to a racked out power circuit breaker. The 12 AWG control cable for the CT's and for the temperature controller shall be lifted on both ends (JEA Relay Technicians will lift the DCS end) and each wire shall be megger tested with 500Vdc to ensure that there are no grounds.

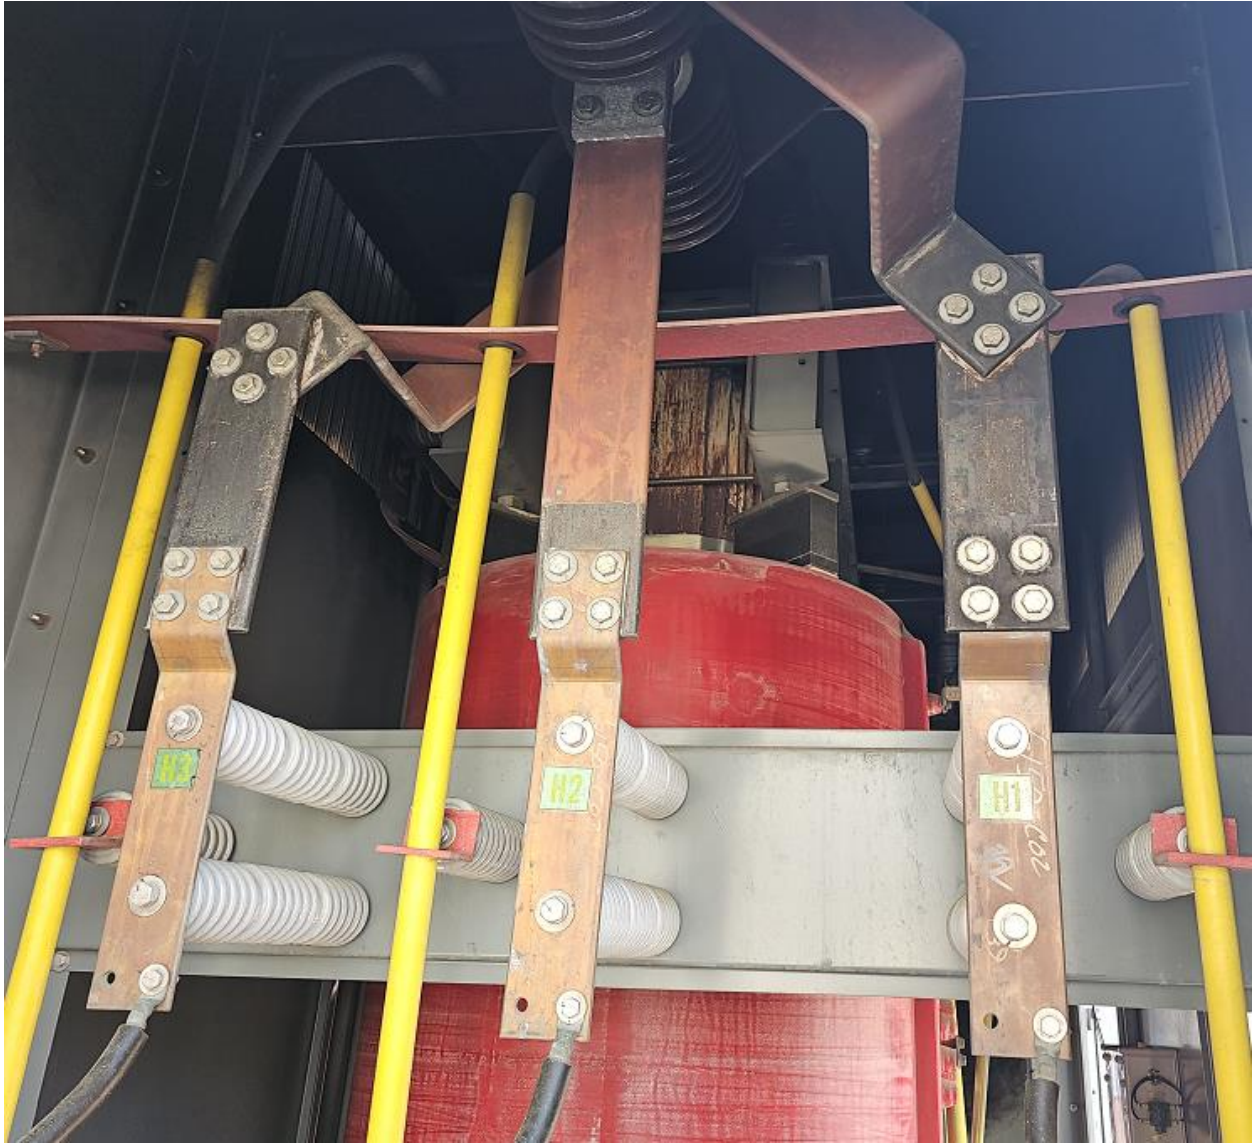
**Primary Bus Bar.**
