**Community Meeting  
September 11, 2019  
Deercreek Subdivision  
Sewer Improvement Project**

- JEA originally contacted regarding settling manholes prior to Deercreek paving project
- Crews discovered problems with connection points to main sewer line from homes – referred to as “T’s”
- Deercreek Subdivision built in early 1980’s
- Most contractors/developers at the time installed ductile iron “T’s” instead of PVC (standard now)
- Ductile iron compromised by sewer gases over the years causing tuberculation and dirt/water infiltration
- “T’s” need to be repaired to prevent infiltration and future roadway issues

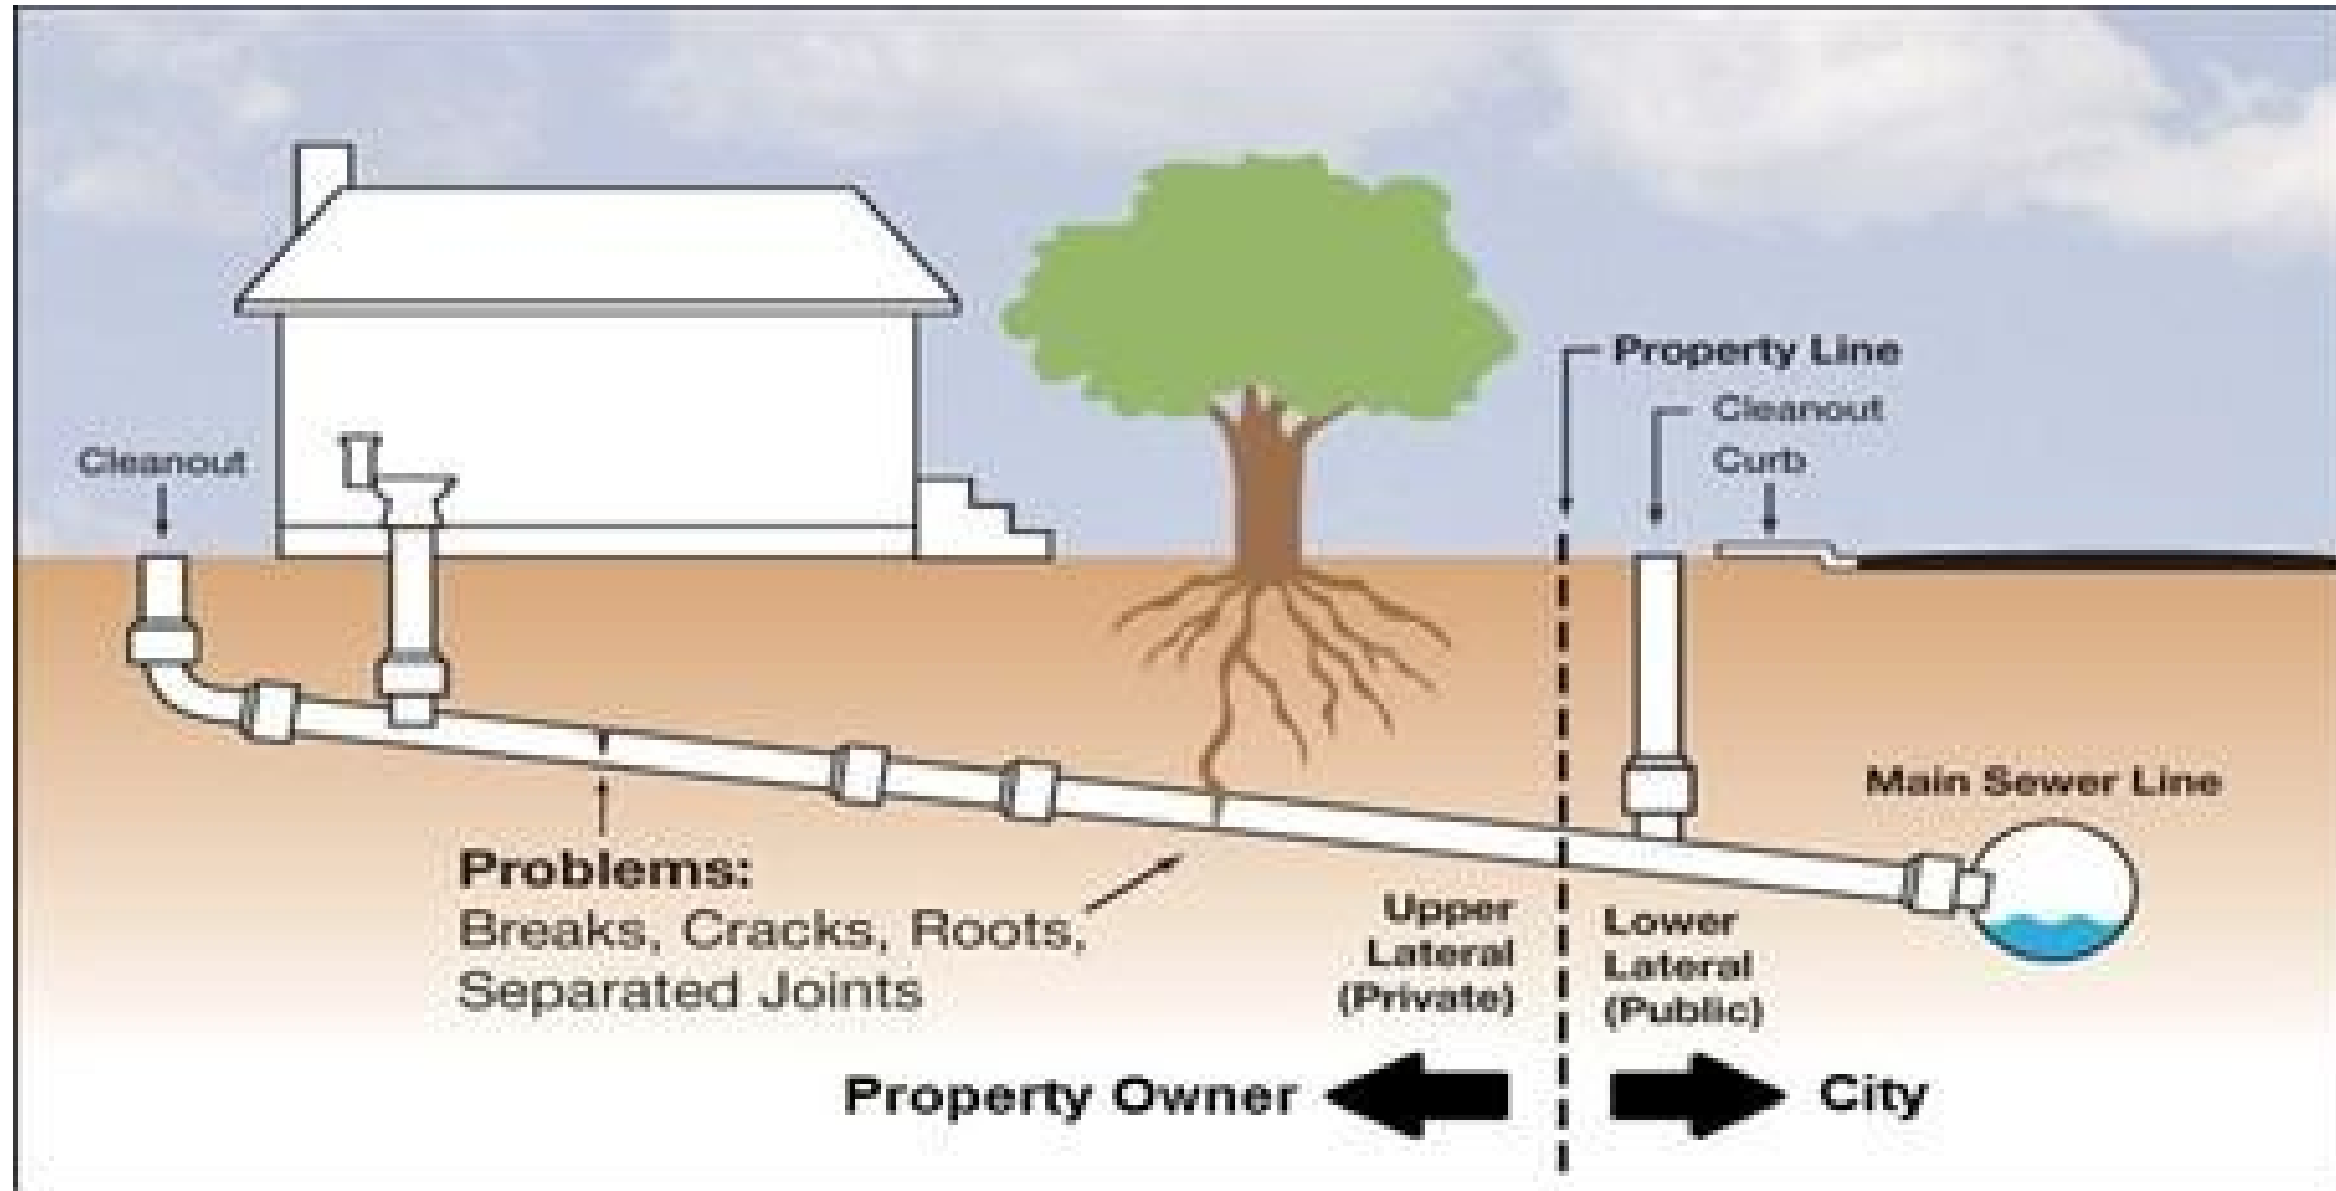
# Residential Sanitary Sewer System
