**TECHNICAL MEMORANDUM**

# 825-12 – Lakeshore Water Plant – Reservoir and Wellhead No. 2 Rehabilitation

PREPARED FOR: Capital Budget Planning

DATE: 2/5/2016

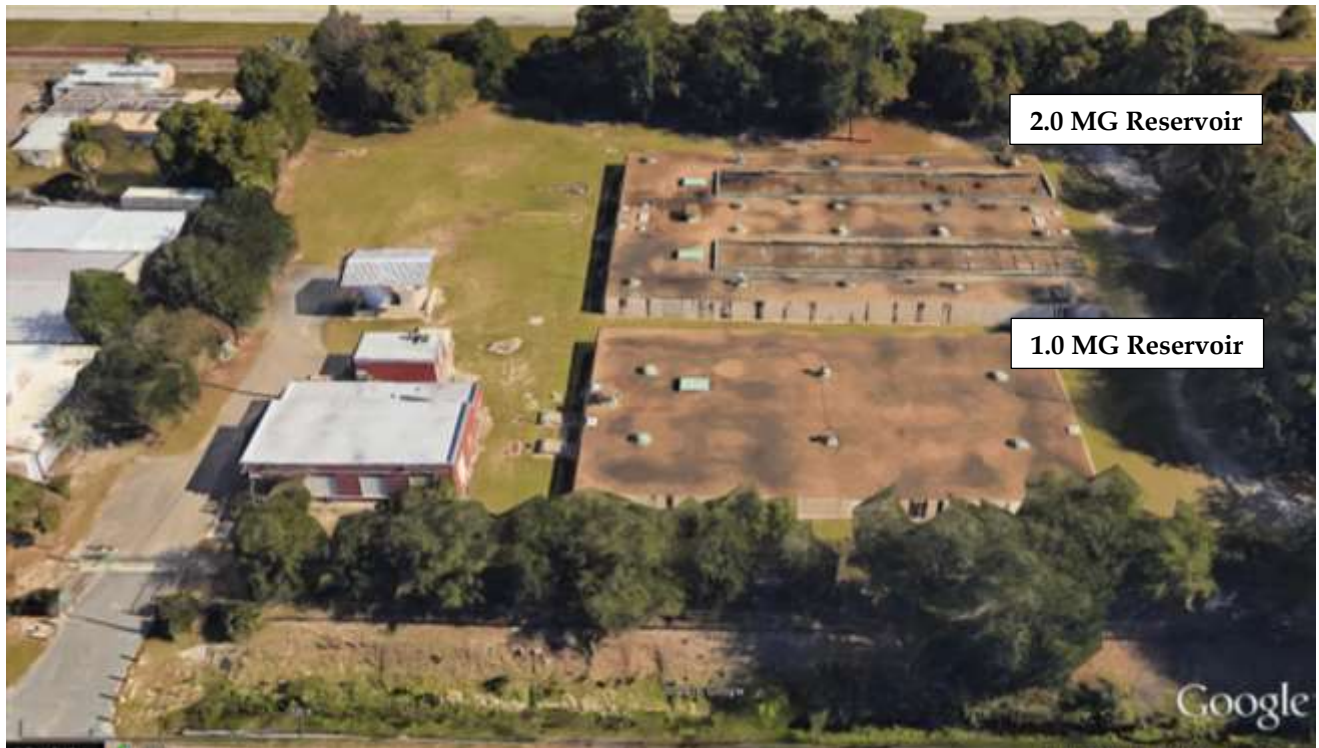
Figure 1: Aerial View of the Lakeshore WTP

The Lakeshore Water Plant is located at 2113 Hamilton Street. The water plant was constructed in the early 1950's. The plant includes source water wells, ground storage reservoirs with fans primarily for hydrogen sulfide removal, sodium hypochlorite system for disinfection and high service pumps for conveying treated water to the distribution system (Figures 1 & 2).
